Technical Report REMR-OM-17  
September 1995

# REMR Management Systems—Navigation Structures, Condition Rating Procedures for Tainter Dam and Lock Gates

# **REMR Management Systems— Navigation Structures Condition Rating Procedures for Tainter Dam and Lock Gates**

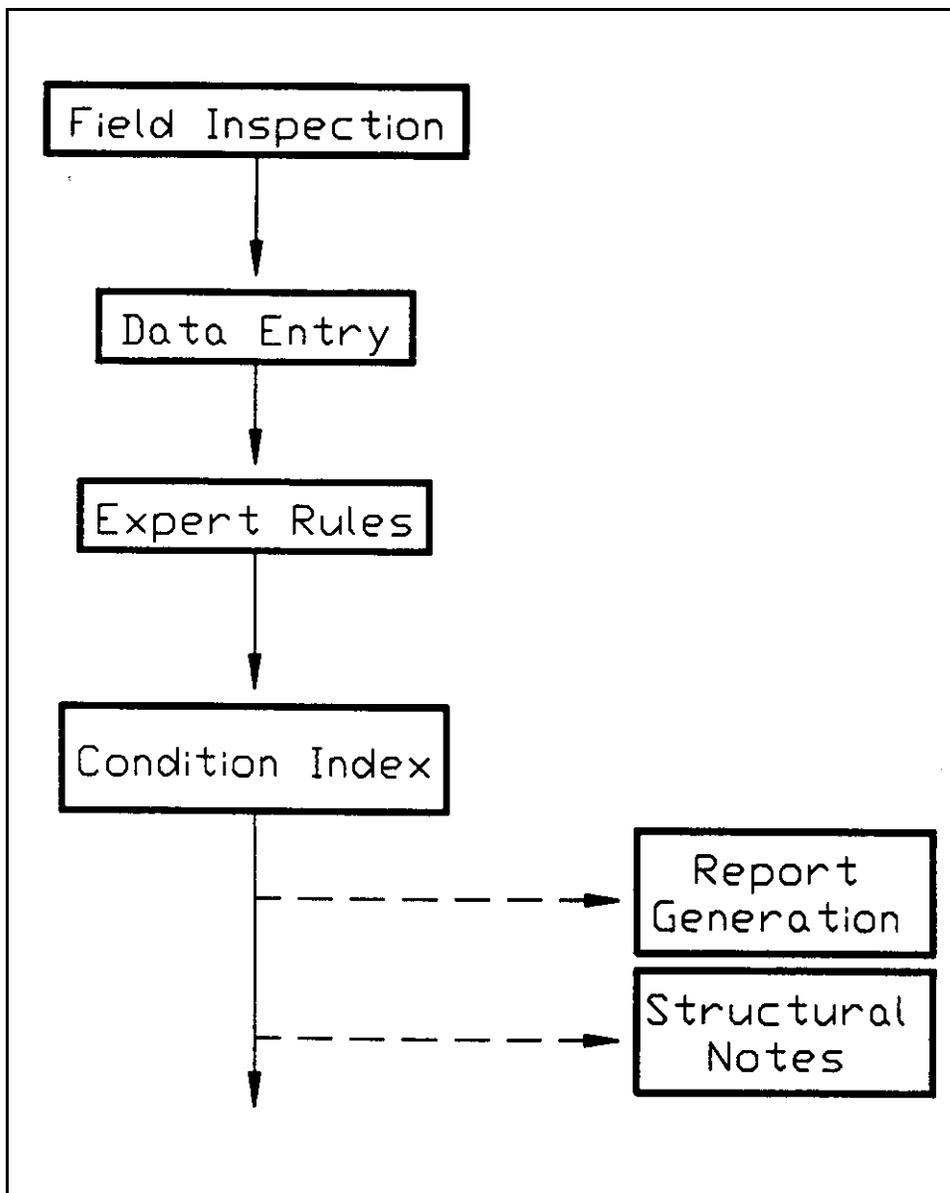
Figure 1. Inspection and rating procedure.

Figure 1 illustrates the inspection and rating procedure. The field inspection is the means of gathering consistent data for any particular tainter dam or lock gate. The first two pages of the inspection form are used to record descriptive data, such as the type and location of the gate, general component information, and maintenance history. Additional pages provide space for field measurement data, such as anchorage assembly deterioration, corrosion, and cracks. The field measurement data is representative of the current state of the structure. All the information collected on the inspection form is entered into a data file on a microcomputer that performs all the calculations necessary to rate the gate.

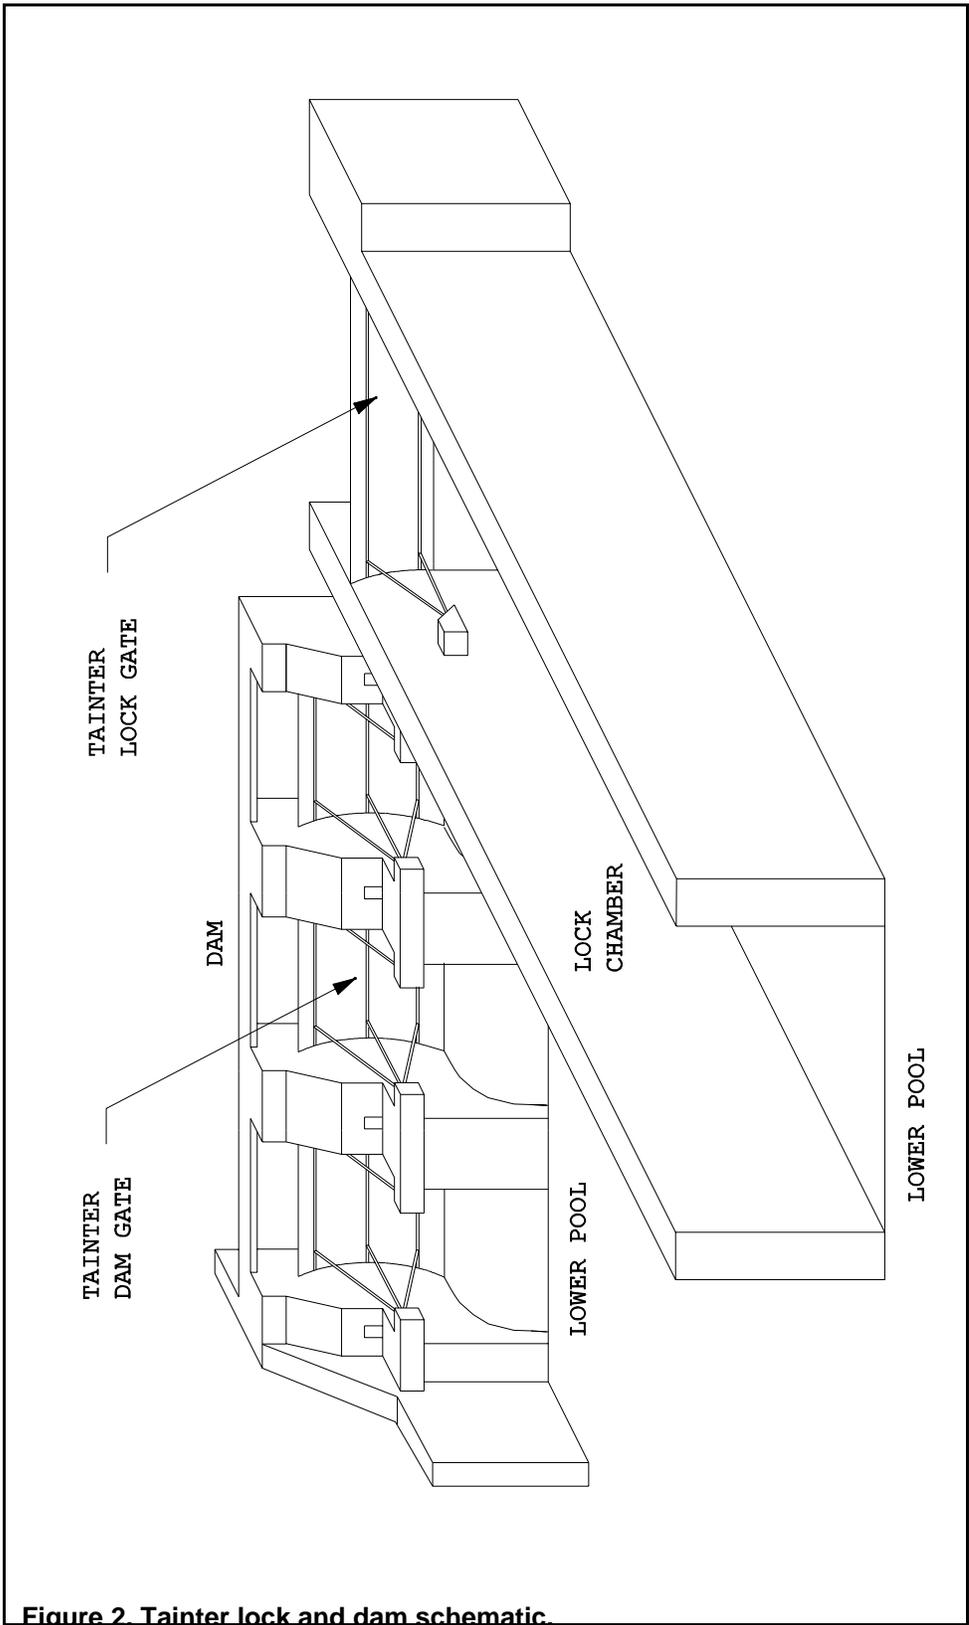
Figure 2. Tainter lock and dam schematic.

Tainter dam gates are used at the top of a dam to control the upper pool elevation, and tainter lock gates operate as upper gates in a lock chamber (Figure 2). Although the function of tainter dam gates and lock gates are somewhat different, their structural components are comparable. Their basic purpose is to hold back and to pass water. Tainter lock gates are submersible; i.e., they are lowered below the sill to allow vessels to pass over them during locking. Some dam gates are partially submersible; i.e., they do not rest on a sill when closed and can be lowered to allow

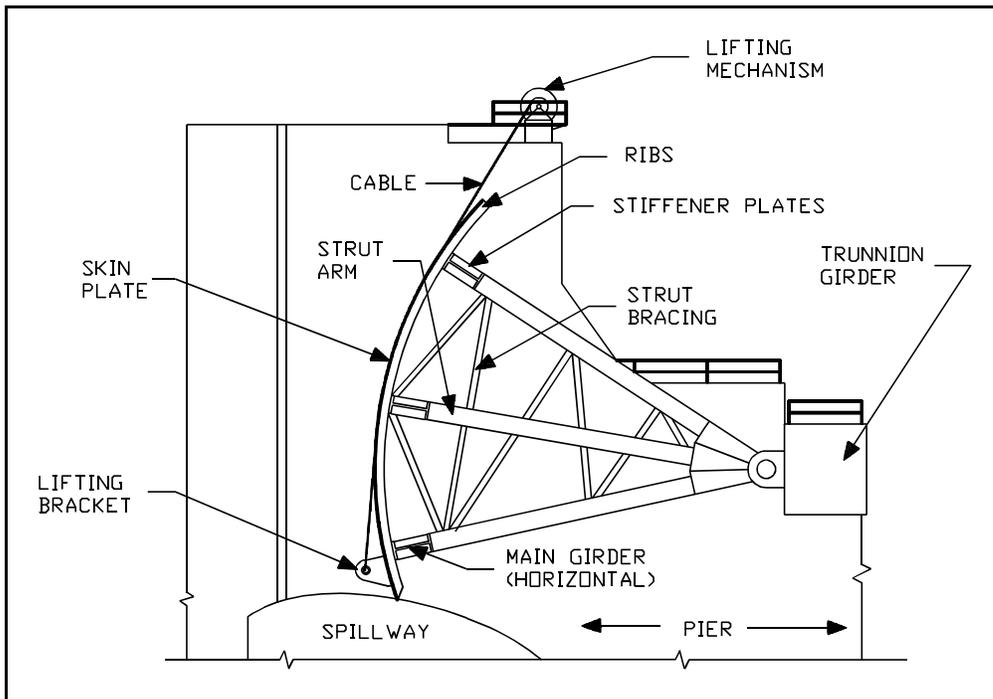
Figure 3. Side view of tainter gate.

**Skin plate:** An upstream skin plate is welded or riveted to the ribs to provide stiffness to the structure (Figures 3, 4, and 5). It dams the water and transfers load to the ribs. A downstream skin plate also may be present.

**Ribs:** The ribs, usually tees, are welded or riveted to the main girders. The ribs transfer load from the skin plate to the main girders (Figures 3, 4, and 5).

**Main girders:** The main girders can be either horizontally or vertically positioned. They span the width or height of the gate and transfer load from the skin plate and ribs to the strut arms (Figures 3, 4, and 5).

**Strut arms:** Strut arms are the steel girders that transfer load from the main girders to the trunnion assembly (Figures 3, 4, and 6). Some strut arms are parallel to the pier face and some slope toward the center of the gate from the trunnion, as shown in the figures.

**Trunnion girder:** The concrete or steel trunnion girder is anchored into the pier or lockwall (Figures 3 and 6). It transfers load from the trunnion yoke to the pier or lockwall.

**Lifting chain or cable:** The lifting chain or cable connects the operating machinery with the gate (Figure 3). It moves the gate between its open and closed positions.

**Lifting bracket:** The lifting brackets are located near the bottom of the gate on either the upstream or downstream side of the skin plate. They connect the chain or cable to the gate structure (Figures 3 and 4).

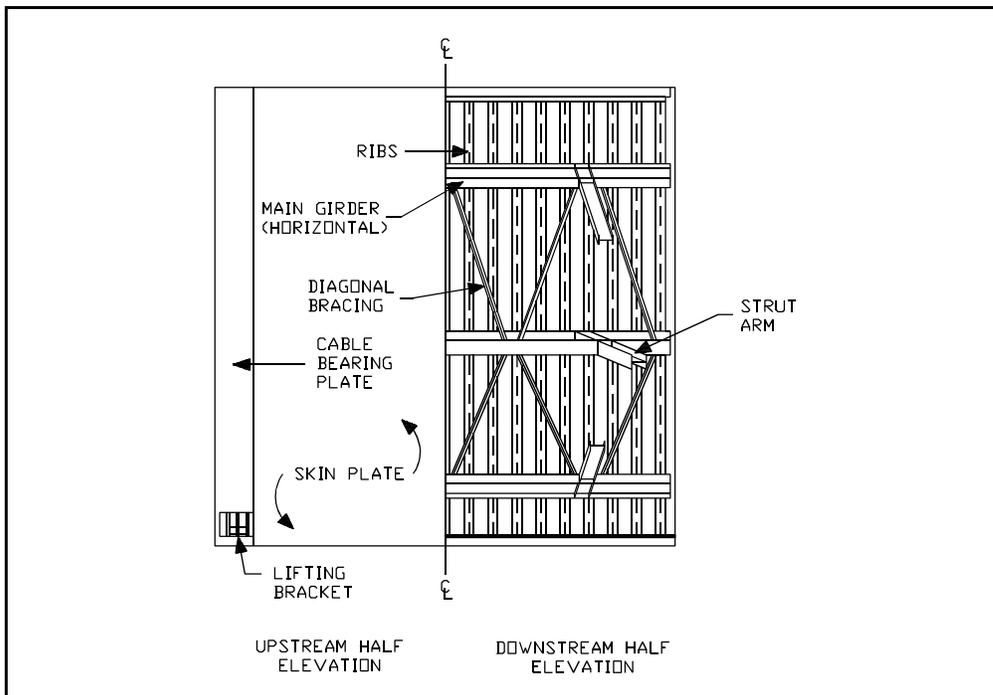
Figure 4. Elevation view of tainter gate.

**Cable or chain bearing plate:** A bearing plate is a thickened or doubled strip of the skin plate or back-to-back channels located on the upstream side (Figure 4). It reduces the wear on the skin plate caused by the sliding contact of the cable or chain as the gate is moved.

**Diagonal bracing:** Diagonal bracing is commonly used across the downstream flanges of the main girders (Figure 4). It aids in the field erection of the gate and adds to its rigidity.

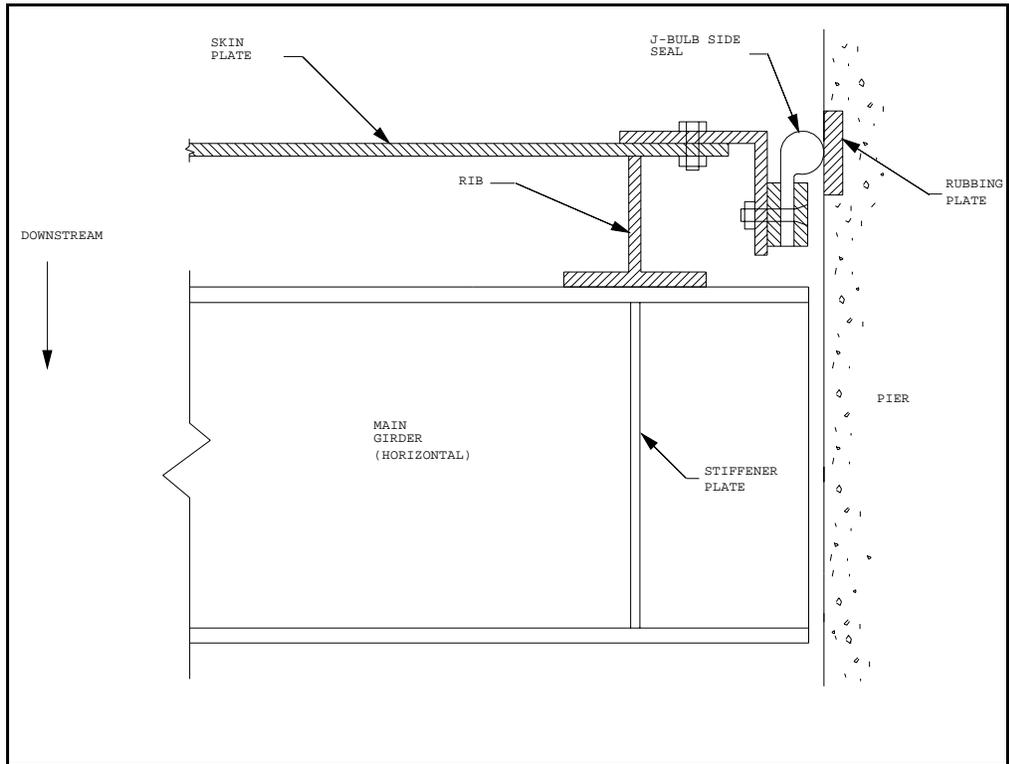
**Figure 5. Side seal detail.**

**Seals:** Rubber seals are used on each side and sometimes on the bottom of a gate to prevent leakage around the gate perimeter (Figure 5).

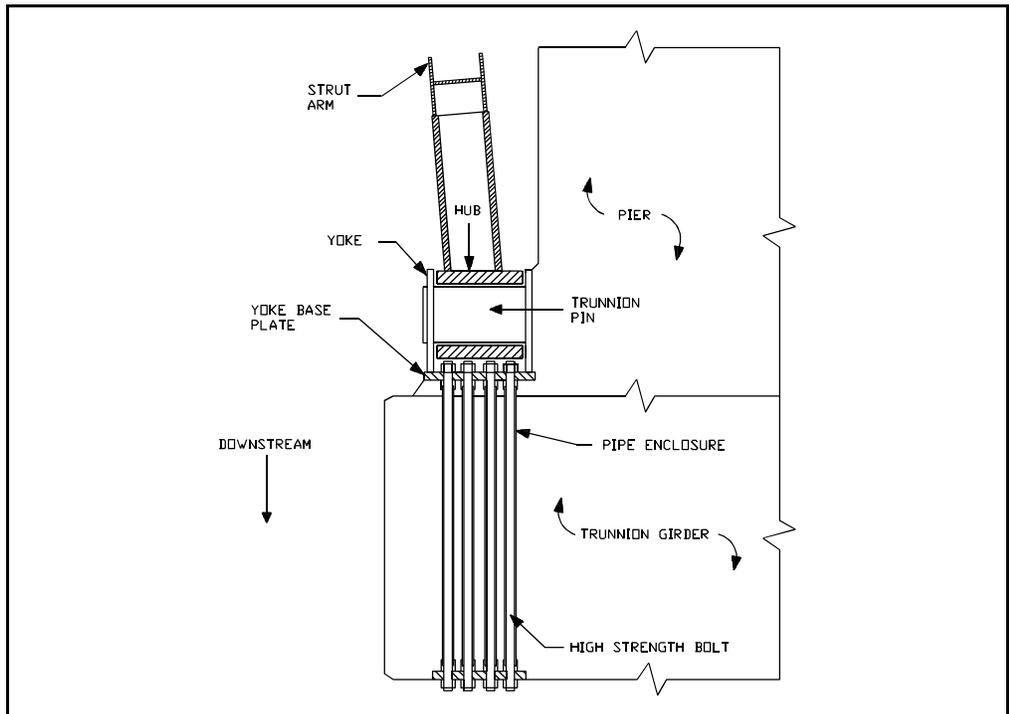
**Figure 6. Example trunnion assembly detail (individual projects differ considerably).**

**Trunnion assembly:** The trunnion assembly consists of a trunnion hub with bronze bushing and heavy flanges, a trunnion yoke, and a trunnion pin (Figure 6). The trunnion assembly transfers load from the strut arms to the trunnion girder.

**Trunnion hub:** The trunnion hub consists of a cylindrical plate and bushing which encompass the hinge pin and transmit load from the strut arms to the trunnion yoke (Figure 6). The flanges align the strut.

**Trunnion yoke:** The trunnion yoke is bolted to the concrete or steel trunnion girder (Figure 6). It transfers load from the trunnion hub to the trunnion girder.

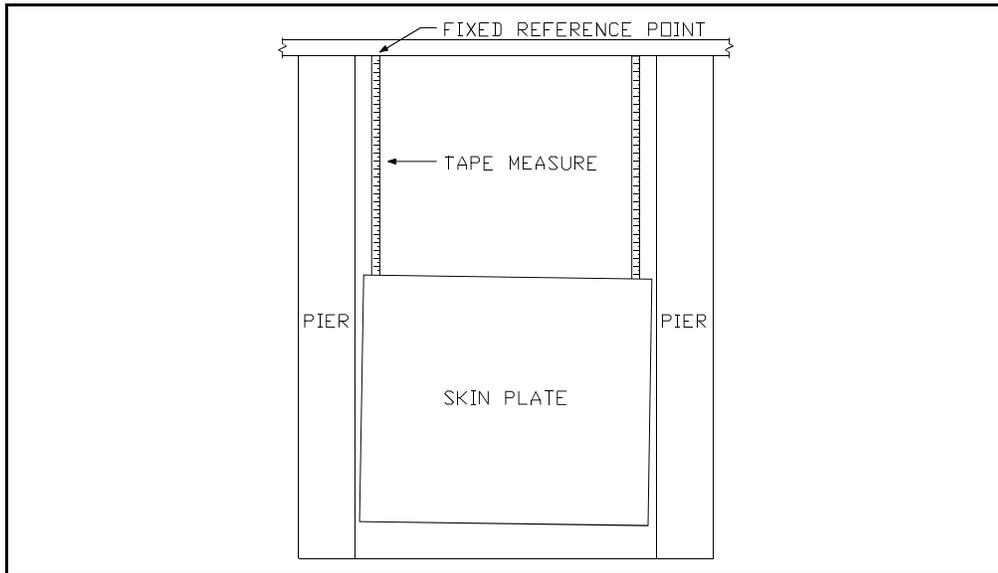
**MISALIGNMENT:** Measurements are recorded with the gate in the closed and 2 ft. open positions and then again in the closed position. Measurements can be made by attaching a tape measure to the skin plate on each side of the gate and recording the distance from a fixed reference point above the gate to the top of the gate (Figure 7). An alternative method of measurement consists of placing an electronic level horizontally along the skin plate and recording the angles (in degrees) at each gate position. (Levels should measure angles to the nearest 0.001 degrees.)

**Figure 7. Misalignment measurement.**

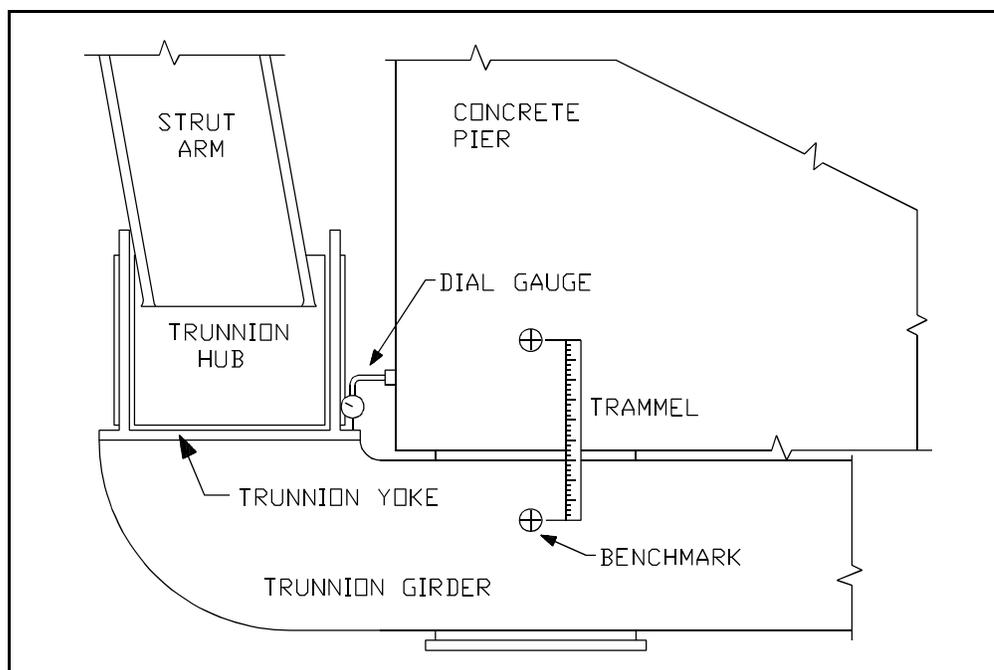
**ANCHORAGE MEASUREMENT:** Measurements of relative movement between the concrete pier and trunnion yoke or girder are taken in the downstream direction (Figure 8). If the inspection is performed under **NORMAL OPERATING CONDITIONS**, dial gauges are used to measure this movement and measurements are taken with the gate in the closed and 2 ft. open positions and then again in the closed position. For tracking relative movement over time, permanent reference points or benchmarks are established on the trunnion girder and on the pier adjacent to the girder. The distance between these points are recorded with the gate in the closed position after the gate has been lifted and reset. A convenient means of doing this is by using a trammel with permanently fixed trammel points for benchmarks. If **BULKHEADED CONDITIONS** exist, dial gauge measurements are taken in the closed position with no head on the gate and with full head on the gate. The term, no head, implies that the water on the upstream face of the gate will be removed by opening the gate. If a tailwater is present on the gate, the upper pool will be equal to the level of the lower pool with no net head. To apply full head or load, lift the bulkhead and flood the gate. Dial gauge measurements should be recorded to 0.001 inch. Trammel measurements between the permanent reference points are taken in the no head condition. Trammel measurements should be recorded as accurately as possible (about 0.0313 in. or 1/32 in.).

**Figure 8. Anchorage measurement.**

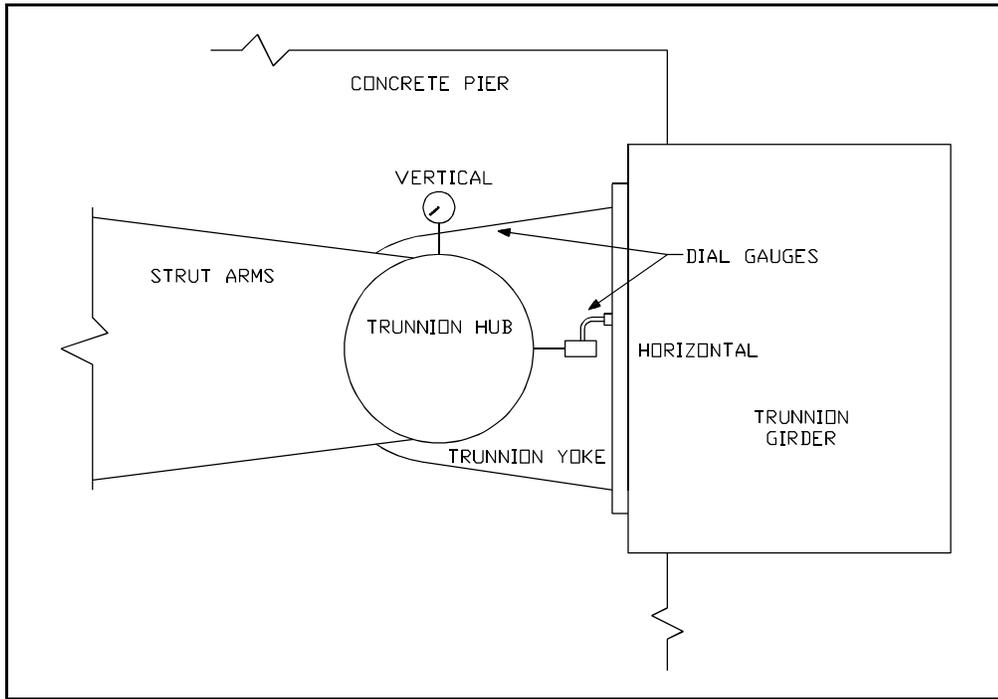
**Figure 9. Trunnion assembly wear measurement: dial gauges.**

**TRUNNION ASSEMBLY WEAR:** Indicate whether the lubrication system is functional. If a unique situation exists, such as a nonlubricated trunnion, NA can be circled. The horizontal and vertical measurements are used to detect motion between the trunnion pin and the bushing. Indicate whether feeler or dial gauges will be used to take the horizontal and vertical measurements. For some gate designs the trunnion pin is exposed and, therefore, it may be possible and simpler to take the horizontal and vertical gap measurements using feeler gauges. Trammel measurements are required.

For an inspection performed under **NORMAL OPERATING CONDITIONS** the horizontal and vertical measurements are made with the gate in the closed and 2 ft. open positions and then again in the closed position. If dial gauges are used to measure the horizontal and vertical movement, it is important that the bearing surface for the dial gauge stem be smooth, with no unevenness, since the trunnion hub rotates. If feeler gauges are used, gap measurements are taken between the pin and bushing in four locations: upstream, downstream, top, and bottom. Horizontal trammel measurements are taken between permanent reference points or benchmarks which have been established in convenient positions on the trunnion hub and yoke. Trammel measurements are recorded in the closed position after the gate has been lifted and reset. Estimate lateral movements and circle correct answer. Gouging occurs when the trunnion hub bears on the trunnion yoke.

The measurements taken in the horizontal,  $X_{HOR}$ , and vertical,  $X_{VER}$ , directions can be made using feeler or dial gauges and trammels (Figures 9, 10, 11). The total motion, no matter what measuring device is used, is calculated by taking the square root of the sum of the squares of the horizontal and vertical movements in each direction:

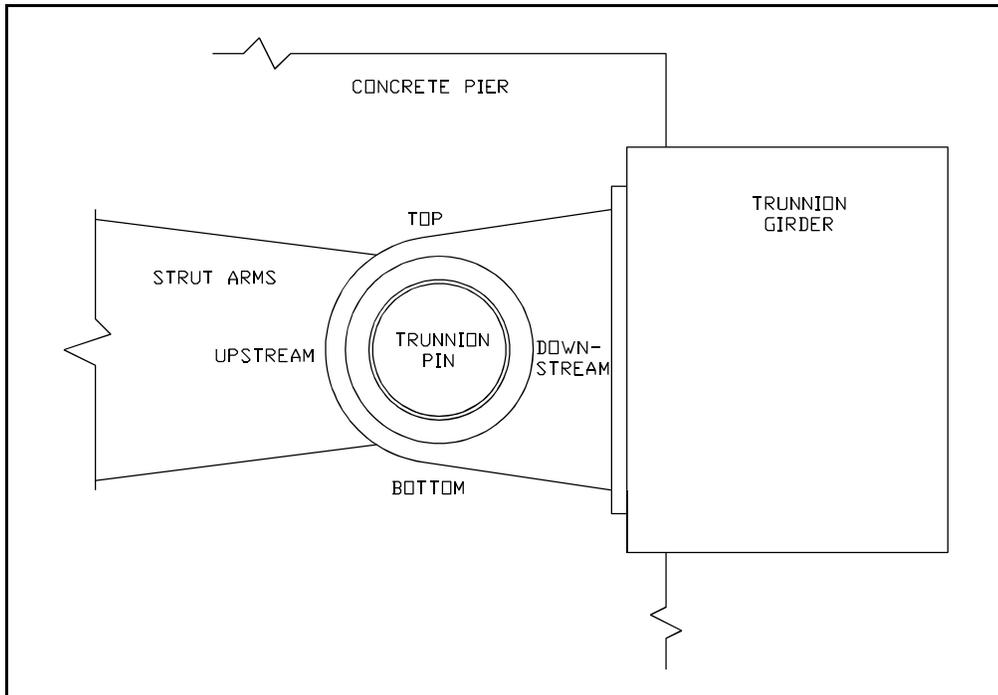
**Figure 10. Trunnion assembly wear measurement: feeler gauges.**

Under **BULKHEADED CONDITIONS** the measurements will be recorded with the gate in the closed position when no head or load is present on the gate and when full head exists. If feeler gauges are used, gap measurements shall be taken between the pin and bushing in the same locations as under **NORMAL OPERATING CONDITIONS**. If dial gauges are used, no special precautions are required to ensure a smooth bearing surface for the stem because the trunnion hub will not rotate. Horizontal trammel measurements are also taken between the permanent reference points for the no head condition.

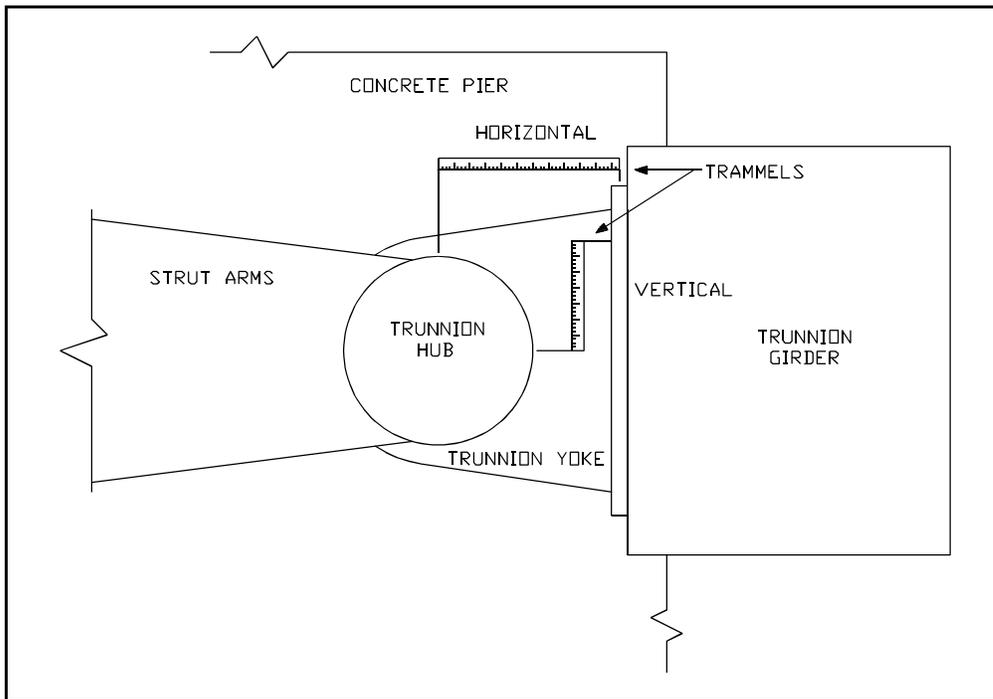
**Figure 11. Trunnion assembly wear measurement: trammels.**

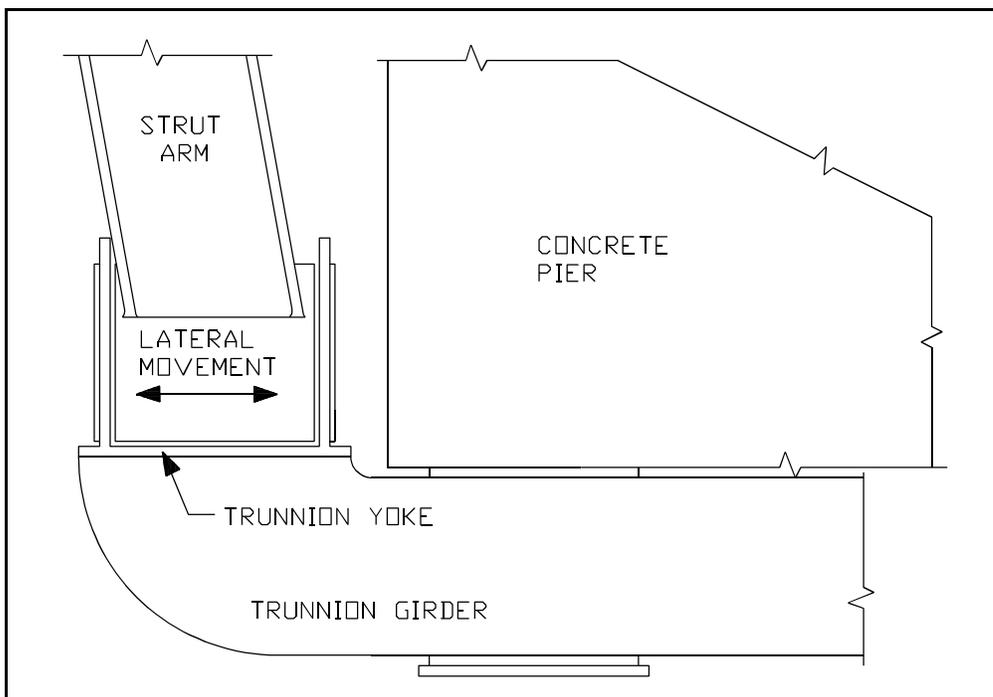
**Figure 12. Trunnion assembly wear: lateral movement.**

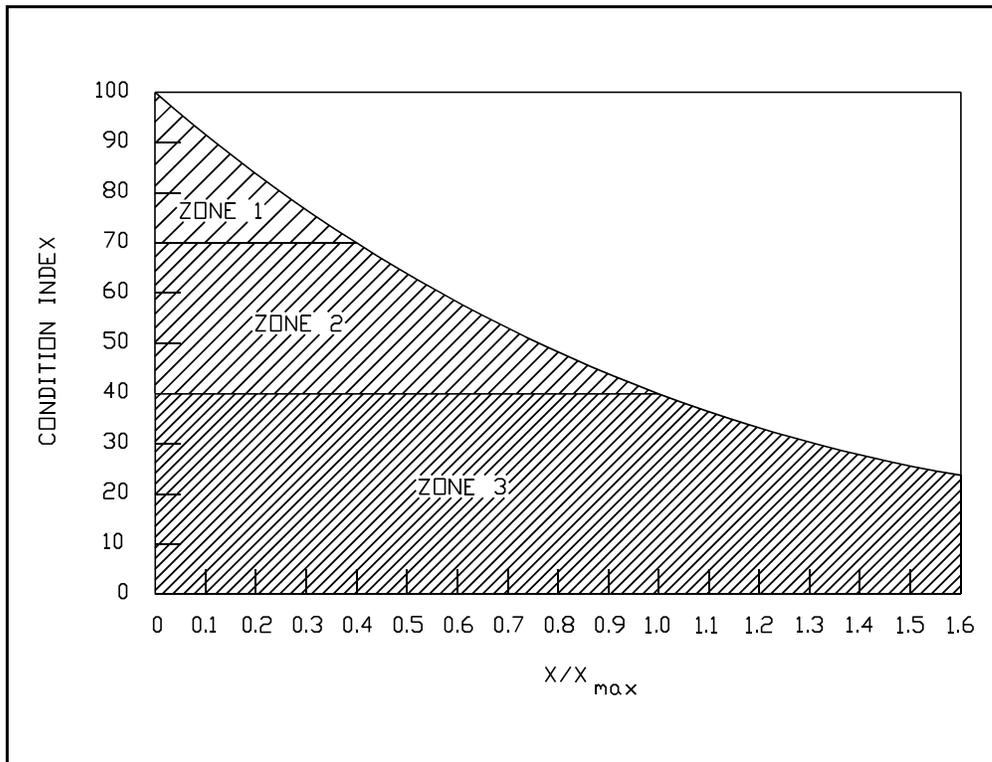
**Figure 13. Condition index related to  $X/X_{max}$ .**

where  $X_{max}$  is some limiting value of  $X$ . The CI zones given in Table 2 define  $X_{max}$  as the point at which the CI is 40, that is, the dividing point between Zones 2 and 3. In other words, the experts have chosen the limiting value  $X_{max}$  to be the point at which a tainter gate requires immediate repair or, at least, a more detailed inspection. Figure 13 illustrates the equation and zones from Table 2.

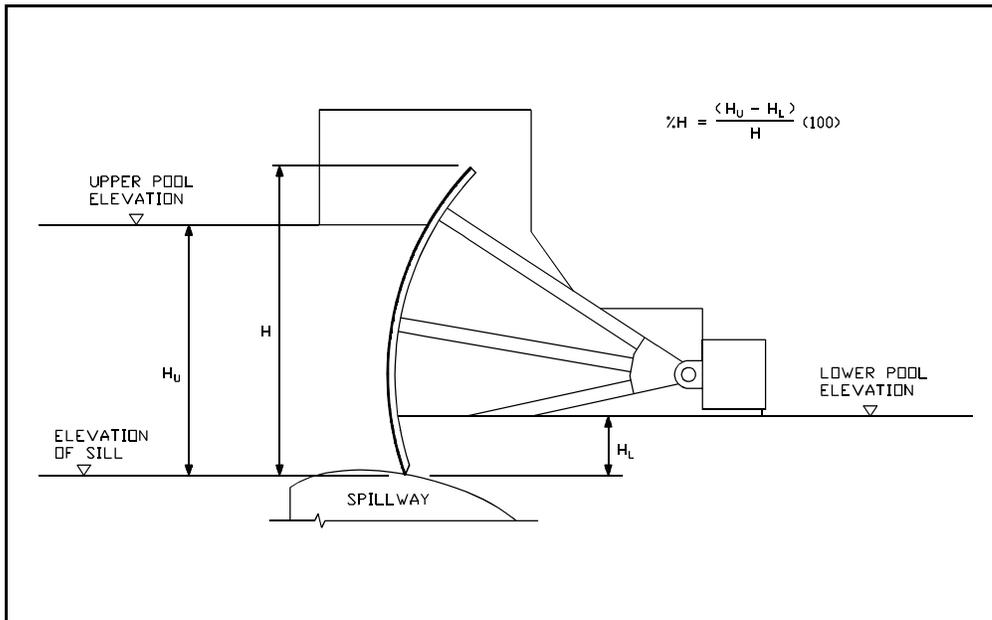
Figure 14. Percent head with tailwater.

*Bulkheaded conditions:* Dial gauges are used to measure short-term movement under bulkheaded conditions. This displacement,  $X_s$ , is the difference between the full-head and no-head readings. The limiting value is dependent upon the percent of head present on the gate, %H, which is equal to the head applied to the gate when the bulkhead is removed, expressed as a percent of gate height, H (Figures 14 and 15). For a rigid anchorage, the limiting values are, if there is less than 20 percent head on the gate,

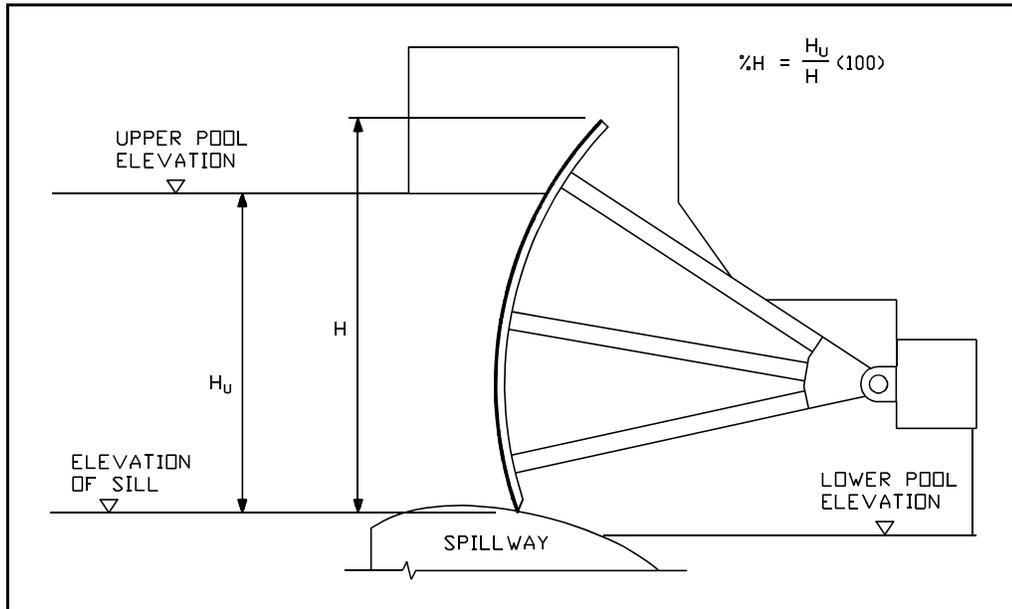
**Figure 15. Percent head without tailwater.**

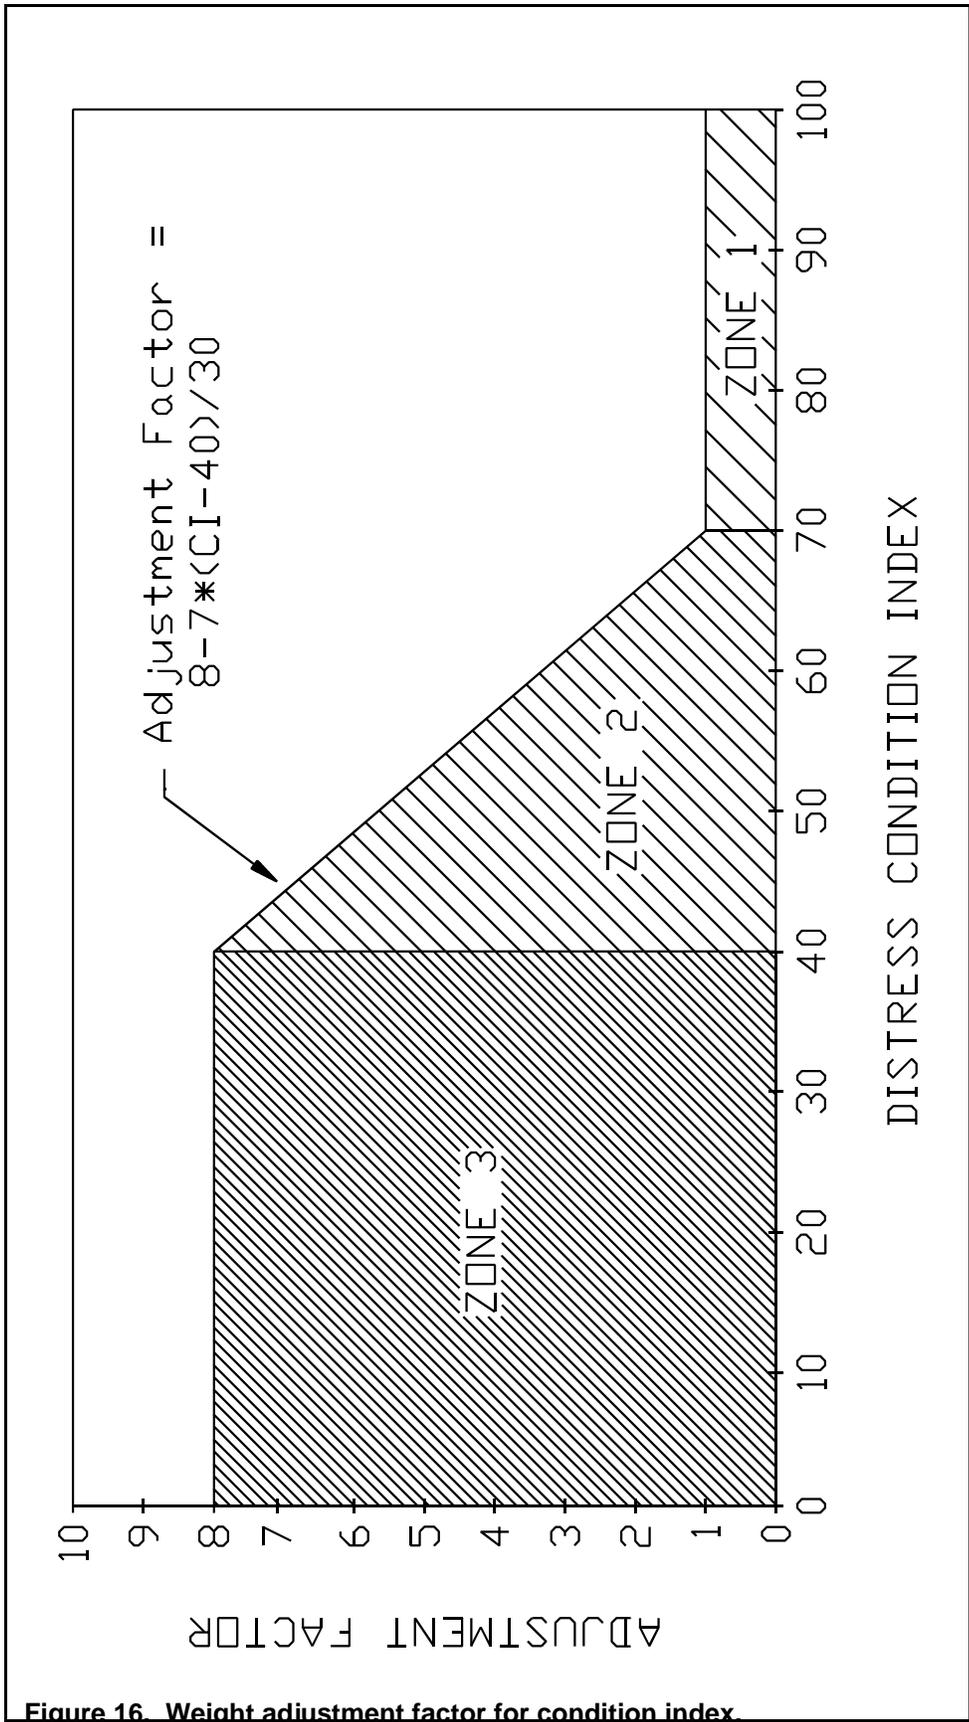
Figure 16. Weight adjustment factor for condition index.

Previous work done by the ISU project team has established that the relative importance of a distress should be greater as the distress becomes more severe. This concept is established by introducing a variable adjustment factor, which will increase the distress weighting factor  $w_i$  as its CI approaches Zone 3. The adjustment factor plotted in Figure 16 has a maximum value of eight; that is, if a distress has a CI that is less than 40, its importance increases eight times.

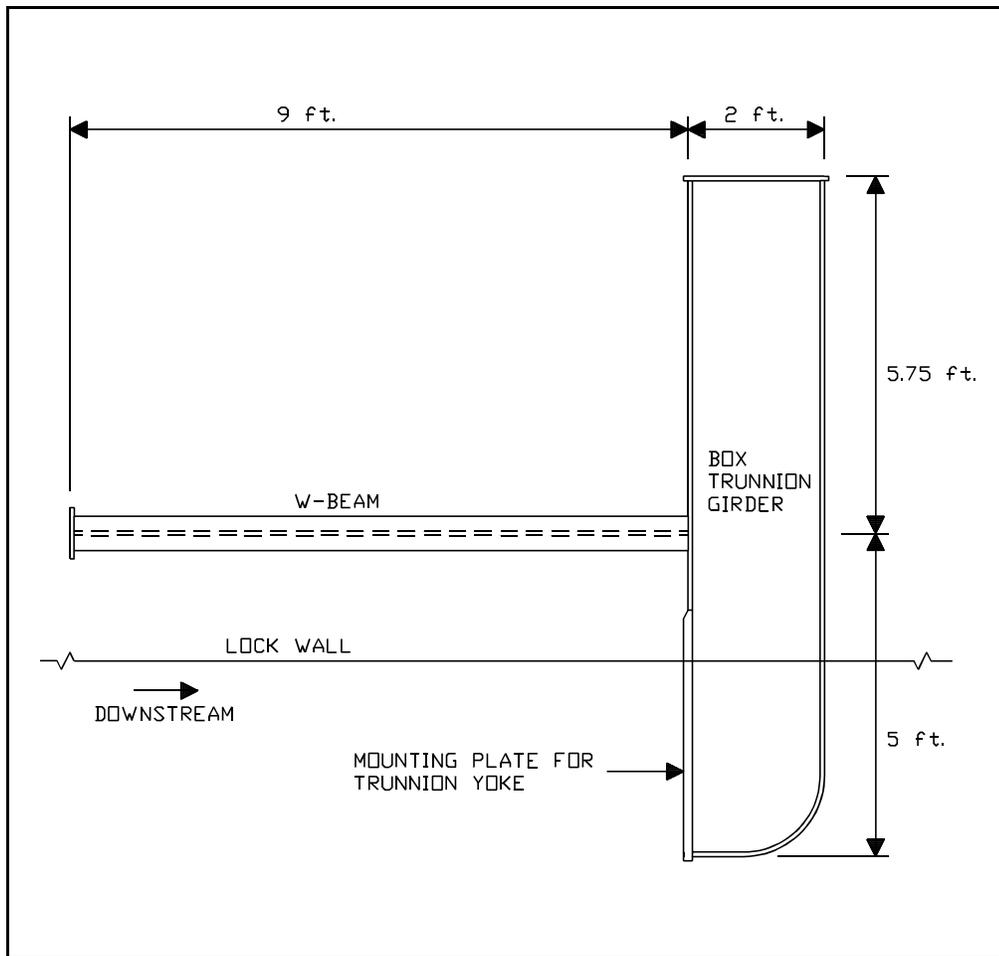
**Figure 17. Flexible anchorage at lower St. Anthony Falls.**

0.065 in. using Eq. 3.16 with an embedment length,  $L$ , of 9 ft, which is the length of the W-beam (Figure 17). The movement measured during the inspection was 0.013 in. The calculated CI would more closely approximate the expert average if the rule, which is based on an allowable axial deformation, included the deformation of the 5-ft box trunnion girder. However, the authors feel that the anchorage configuration is unique, and therefore an analysis is not warranted. Long term movements could not be determined because only current readings were available. The accuracy of trammel measurements may not be sufficient.

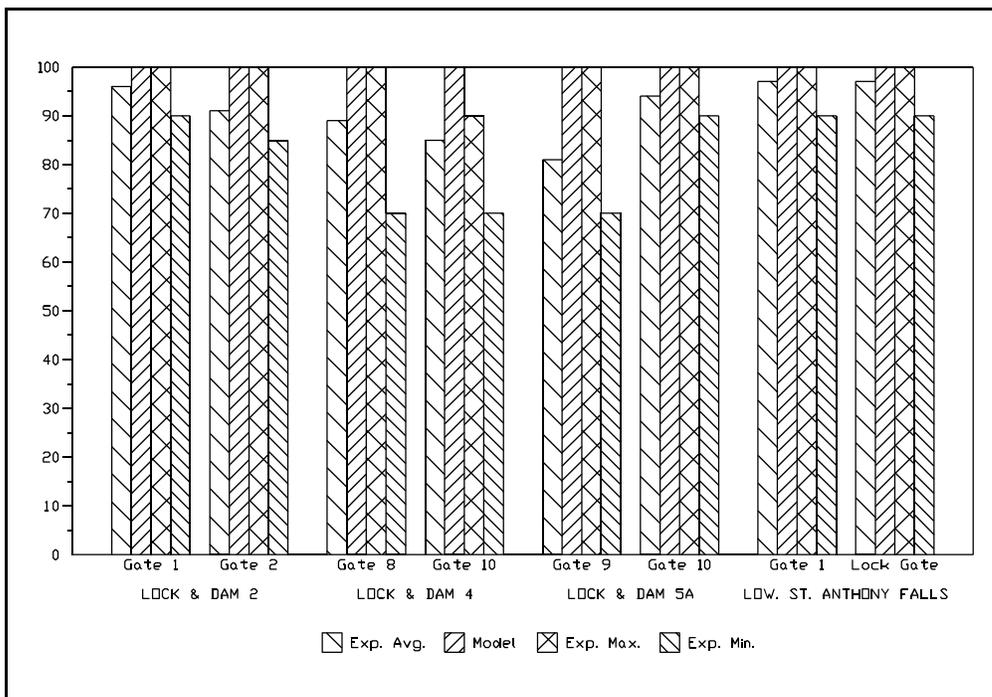
Because no abnormal noise, jumping, or vibration was recorded, the calculated CI values were 100. Although no abnormal distress information was recorded, the experts did not give this distress a perfect rating. Normal vibration was observed on Gate 2 at Lock and Dam (L&D) 2 and on Gate 10 at L&D 4; also, normal noise and vibration were observed on Gate 9 at L&D 5A. The experts may have rated this distress lower than 100, particularly on the gates where normal occurrences were observed, because they did not feel that a distress CI should be 100 if the structure was not new. This phenomena is consistent with what experts have felt about previous structures. Gate 8 at L&D 4 has an expert average rating of 89, which is unexplainably low because no normal or abnormal occurrences of this distress were recorded.

Figure 18. Noise, jumping, and vibration.

## Noise, Jumping, and Vibration (Figure 18)

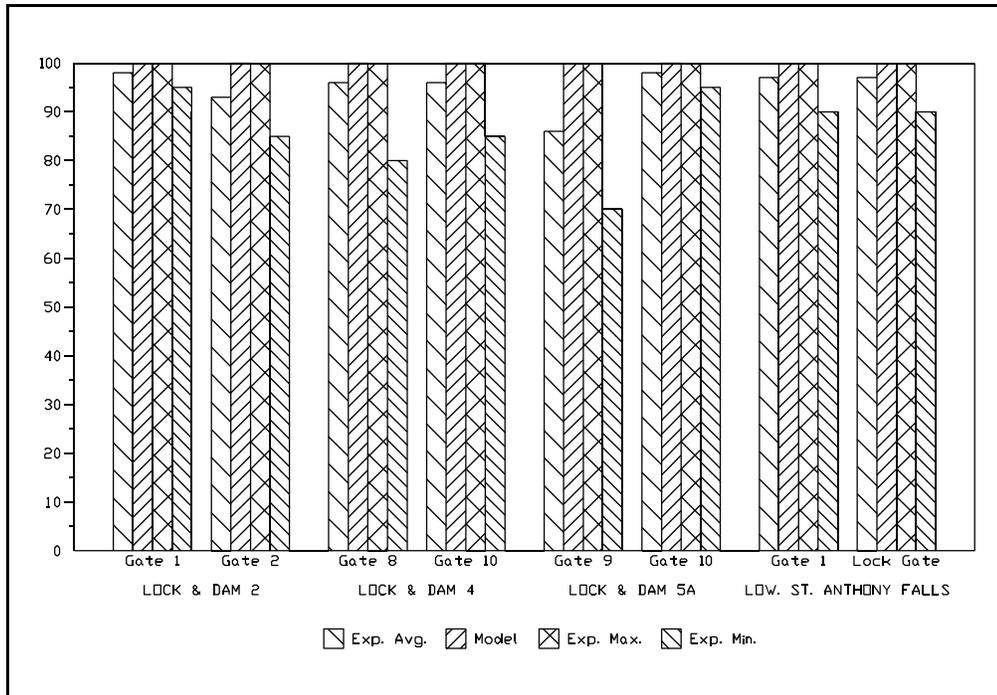
Again the calculated CIs for each gate were 100 and the experts rated the gate lower. Level 1 gate vibration was experienced on Gate 2 at L&D 2 and on Gate 9 at L&D 5A, which explains the lower-than-normal expert average rating for these two gates. However, the vibration disappeared when the position of the gates was adjusted and, therefore, the calculated CI was 100.

**Figure 19. Vibration with flow summary.**

## Vibration With Flow (Figure 19)

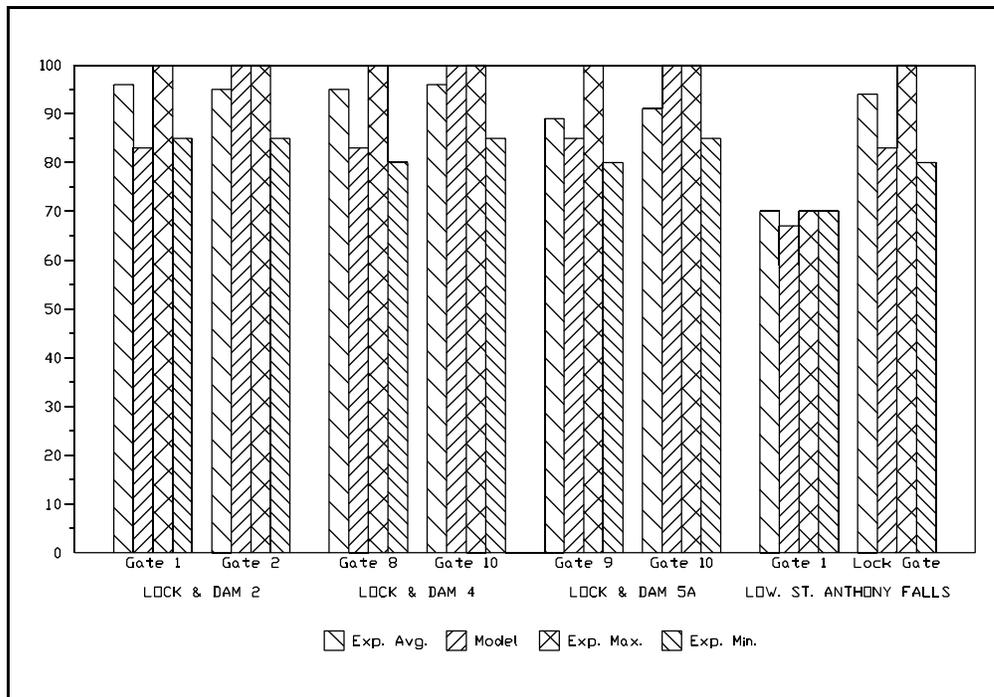
The calculated anchorage assembly CIs closely approximated the expert averages, except for Gate 1 at L&D 2, Gate 8 at L&D 4, and the lock gate at Lower St. Anthony Falls. Movements of 0.001 in. were recorded for Gates 1 and 8, which result in a calculated CI of 83. The experts assigned a limiting  $X_{max}$  value of 0.005 in. for rigid anchorage motion under normal operating conditions. However, the higher CIs assigned by the experts do not support the appropriateness of this limiting value, and suggest that  $X_{max}$  should be increased. Nevertheless, the authors feel that the movement is significant, especially because the load variation on the gate is small under a normal operating condition, and that the calculated CI is appropriate. The calculated CI for the lock gate at Lower St. Anthony Falls was 11 points lower than the expert average. The limiting value for flexible anchorage movement is

**Figure 20. Anchorage assembly deterioration.**

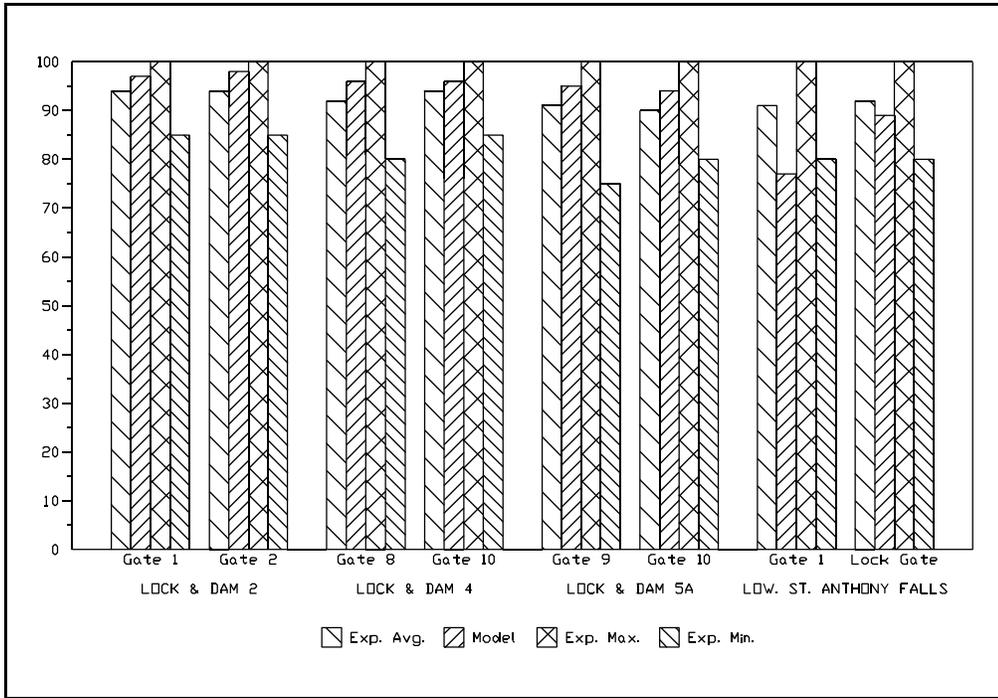
Figure 21. Trunnion assembly wear.

## Trunnion Assembly Wear (Figure 21)

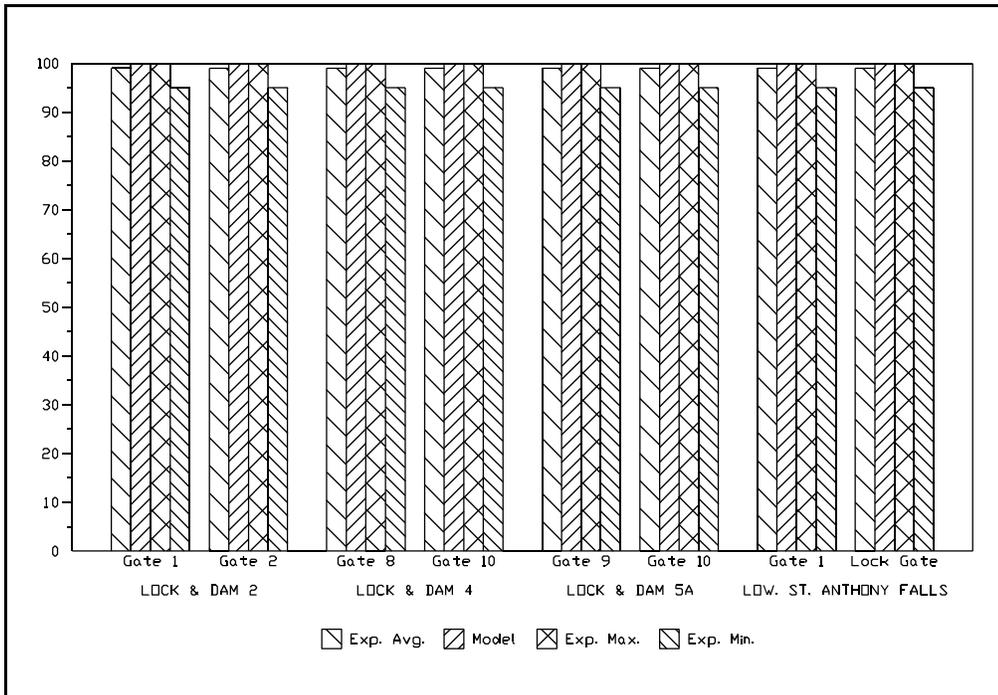
No cracks were recorded on any gate, resulting in a calculated CI of 100 for the crack distress on each gate. Similar to the noise, jumping, and vibration distress, though, the experts rated the gates slightly lower than 100.

Figure 22. Cracks.

## Cracks (Figure 22)

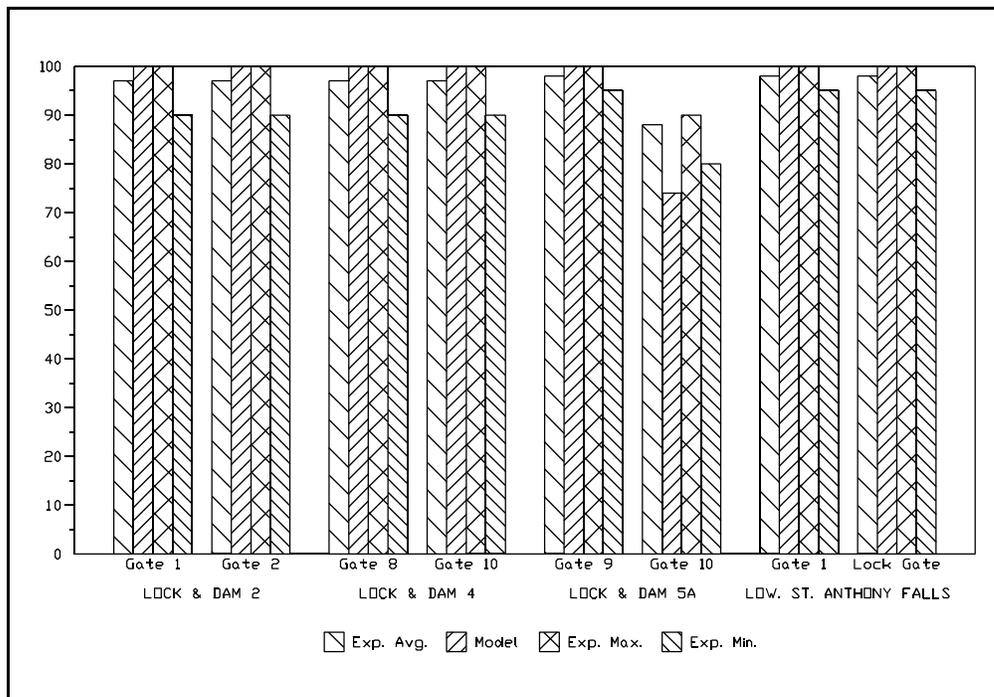
The only dents recorded in the field test (three on the skin plate and one on the ribs) were on Gate 10 at Lock and Dam 5A. The calculated CI describing the dent condition was 14 points lower than the expert average for this gate. This calculated CI was controlled by the rib dent; however, the CI calculated for the skin dents was only two points higher at 76. As future inspections are performed, it may be necessary to increase the value of  $X_{max}$  to better reflect the condition of a gate. The more conservative  $X_{max}$  is appropriate at this time.

Figure 23. Dents.

## Dents (Figure 23)
