Technical Report REMR-OM-17  
September 1995

# REMR Management Systems—Navigation Structures, Condition Rating Procedures for Tainter Dam and Lock Gates

# **REMR Management Systems— Navigation Structures Condition Rating Procedures for Tainter Dam and Lock Gates**

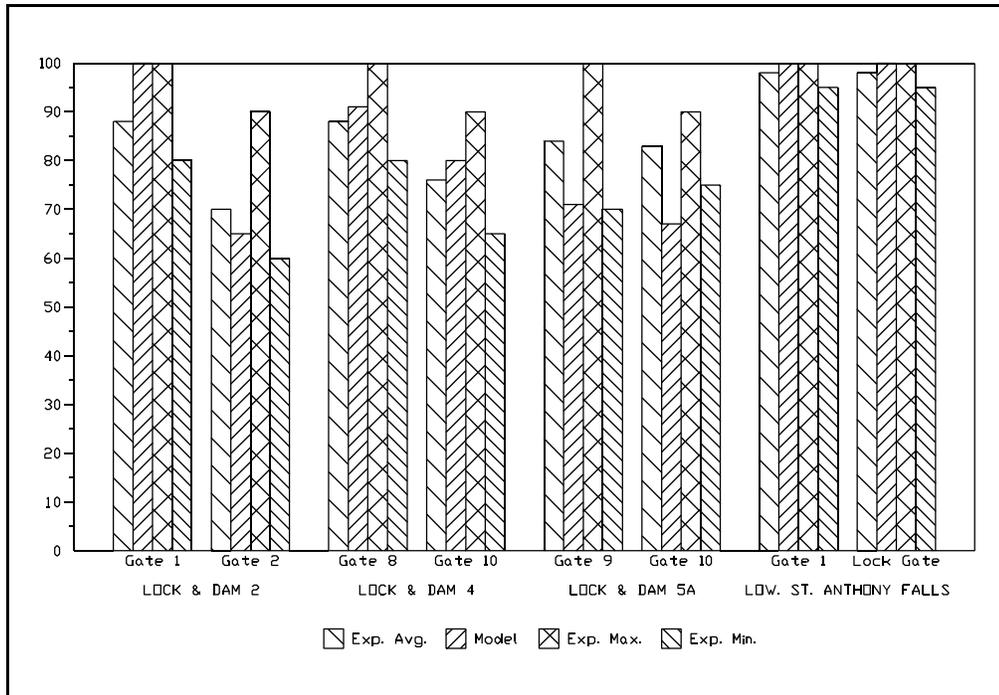
No corrosion or erosion was recorded on Gate 1 at L&D 2 and the gates at Lower St. Anthony Falls. The expert average for Gate 1 at L&D 2 cannot be accounted for by the authors. Strut arm corrosion was the controlling CI for Gate 10 at L&D 4 and the gates at L&D 5A. The calculated CI for Gate 10 at L&D 4 compared well with the expert average. The gates at L&D 5A, however, had calculated CIs that were substantially lower than the expert average. The calculated CI values for Gate 2 at L&D 2 and Gate 8 at L&D 4 correspond relatively well with the expert averages. The corrosion was recorded on the inspection form using primarily the percentage area method.

Figure 24. Corrosion/erosion.

## Corrosion/Erosion (Figure 24)

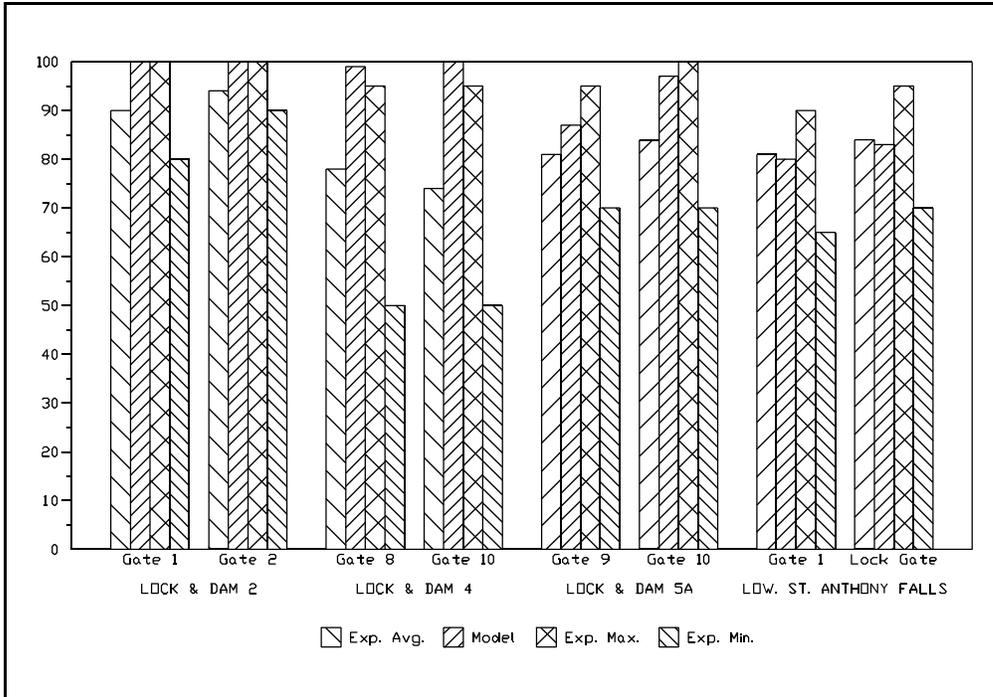
Figure 25. Leaks.

The following bar charts (Figures 18 to 25) present the experts' subjective CI versus the CI calculated by Chapter 3 rules for the distresses associated with tainter dam and lock gates. Each graph is for an individual distress. Within each group of data are four columns of data that represent

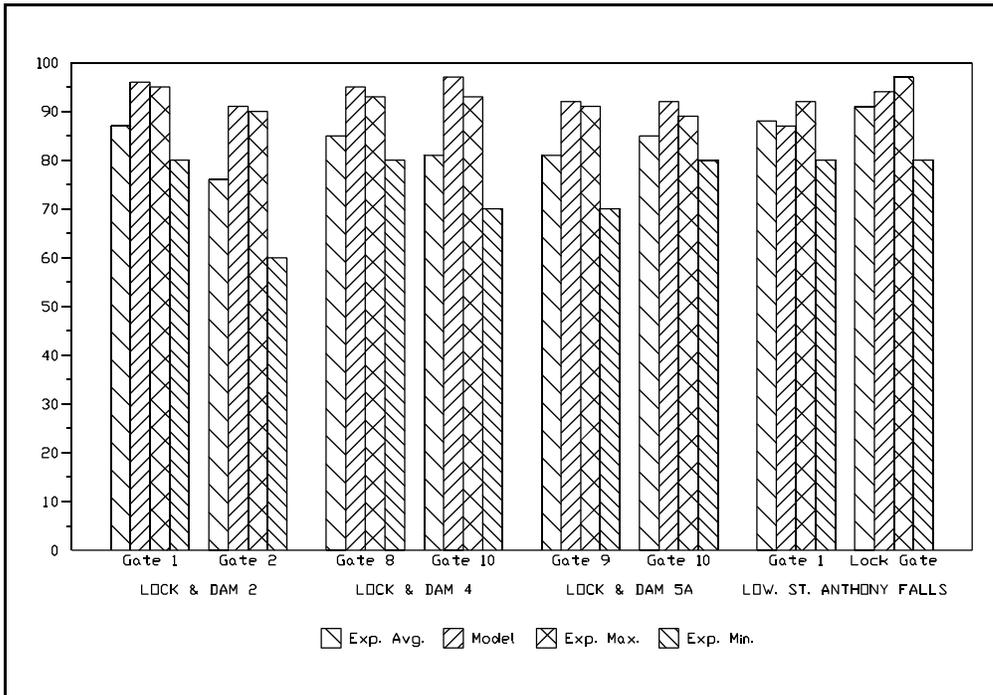
The overall gate ratings from the calculated model tended to track higher than the expert average, except for Gate 1 at Lower St. Anthony Falls, which was

Figure 26. Overall ratings for the gates.

slightly lower. The primary reason that most calculated CIs were higher is that the experts based their overall gate rating on the lowest individual distress CIs, generally leak and corrosion CIs, without considering the other distresses.

The results of a comparison between the expert rating and the calculated values for each distress are summarized below. In addition, there is a comparison for the overall CI of each gate (Figure 26).

## Overall Gate Ratings (Figure 26)
